Drainage Alternatives Study

Bolger Hill Road Drainage Improvement Project Jericho, Vermont

January 2020

Technical Memo

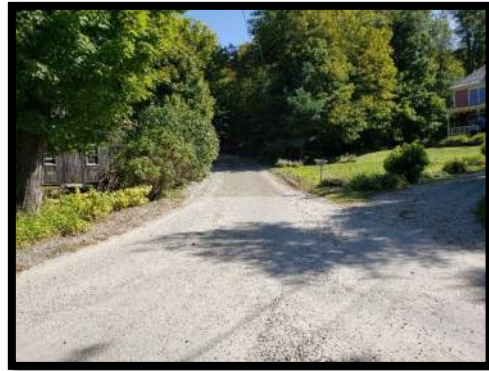
Photo A: Bolger Hill Road at Drive to House #4 drive

During a site visit in September 2019, Hoyle, Tanner observed gravel on the pavement of the lower portion of Bolger Hill Road near the intersection of Jericho Center Circle. Review of the area indicates potential sources of the gravel include the drive to House #4, shown in Photo A. This drive is constructed of loose gravel and leaves Bolger Hill Road at a steep upgrade. There are no ditch lines along the driveway and during rain events, it appears stormwater flows down the drive and onto Bolger Hill Road, likely dislodging fine gravel in the process. This gravel would collect where the roadway levels off, at the intersection between Bolger Hill Road and Jericho Center Circle.

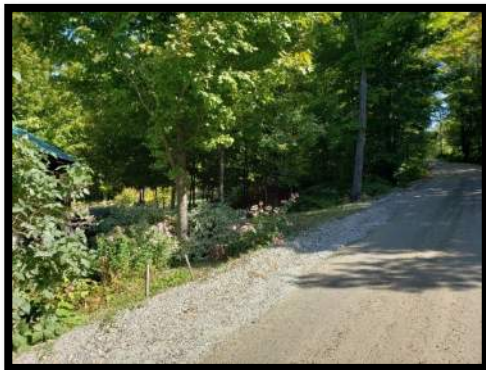
Photo B: Loose Shoulder Gravel

There is also evidence that loose gravel along the shoulders of Bolger Hill Road (Photo B) contribute to the issue of the deposits found in the Town Green. This material is looser than the material typically traveled by the vehicles and is more easily picked up in stormwater and conveyed downstream. This was evident by the minimal rill erosion present within the traveled way and the more extensive rill erosion present within the shoulders (see Photo C). Photo B shows the more compacted and less erodible gravel within the travel way and the looser, more erodible gravel along the shoulder. This is indicated by the different colors of the gravel.

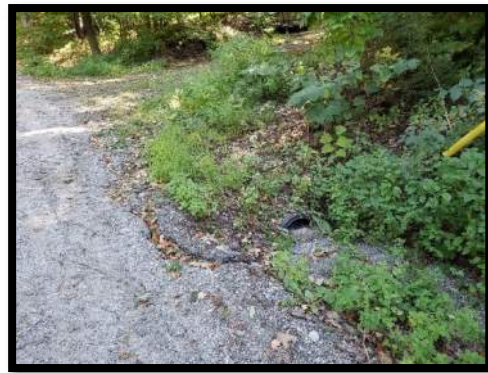
Photo C: Rill Erosion Along the

The southern roadside ditch line ends at the beginning of the established lawn for House #4 (station 101+50), which also marks the start of the roadside berms on this side of the road due to the maintenance of the gravel road (maintenance berm – Photo D). Where maintenance berms are present the stormwater cannot leave the roadway surface and therefore is likely to pick up gravel particles and convey them downstream and into the intersection. With no outlet (or continuation) to the ditch line, if the stormwater cannot infiltrate quickly enough, it will overtop the ditch line and run along the edge of the roadway shoulder.

Along the northern side of the roadway, the Town has created turnouts in the maintenance berm to divert the stormwater which is flowing along the shoulders, off the roadway and over the roadside fill slopes. This, however, causes the concentrated flow to erode the side slopes and the land of the abutting properties.

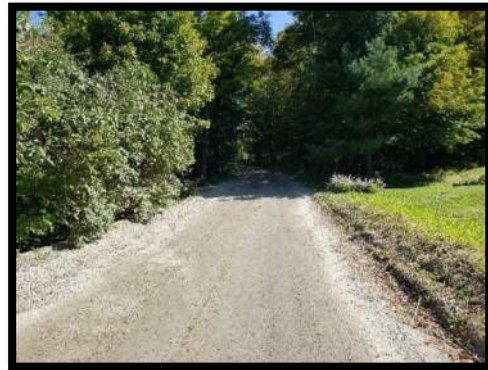
Photo D: Maintenance Berms by
House #4

The steepness of the roadway profile and lack of roadway cross slopes also affect the stormwater's ability to leave the roadway surface. Photo D shows the lower portion of the roadway, near the intersection, where there are no ditch lines and a maintenance berm is present.

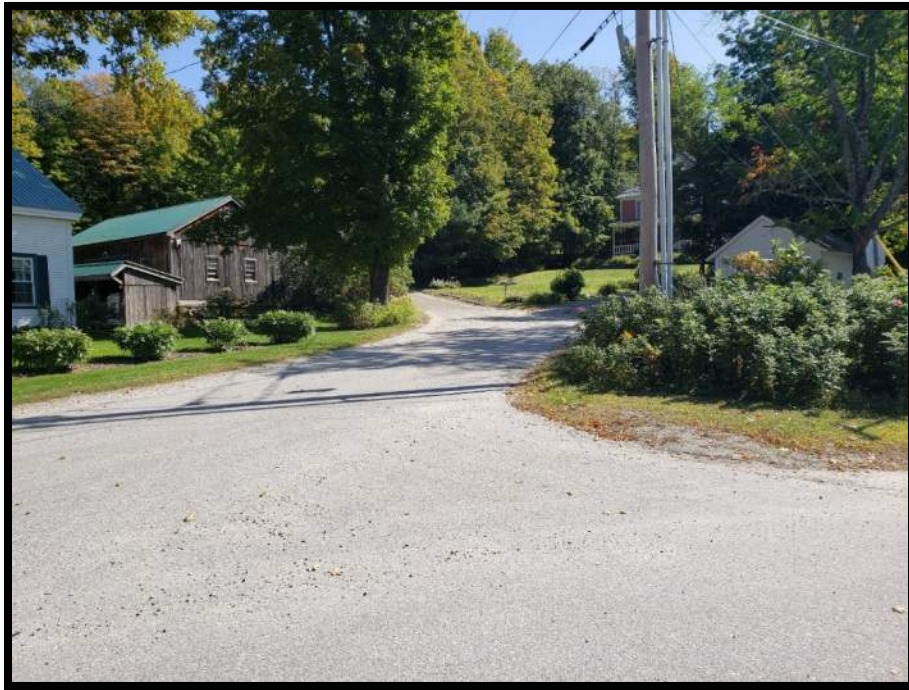
Bolger Hill Road at Jericho Center Circle

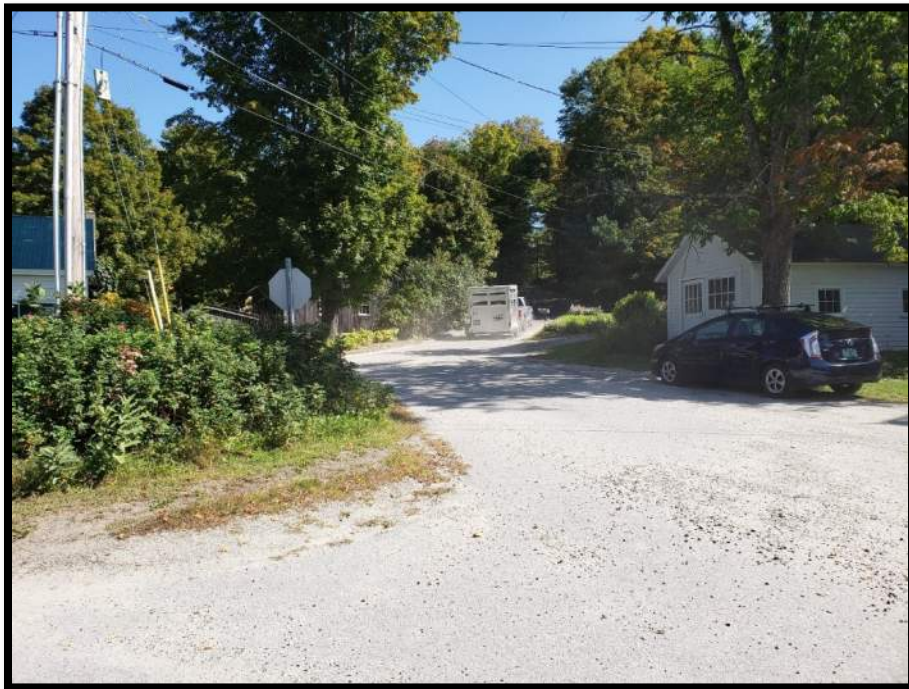
Gravel on Bolger Hill Road at Intersection

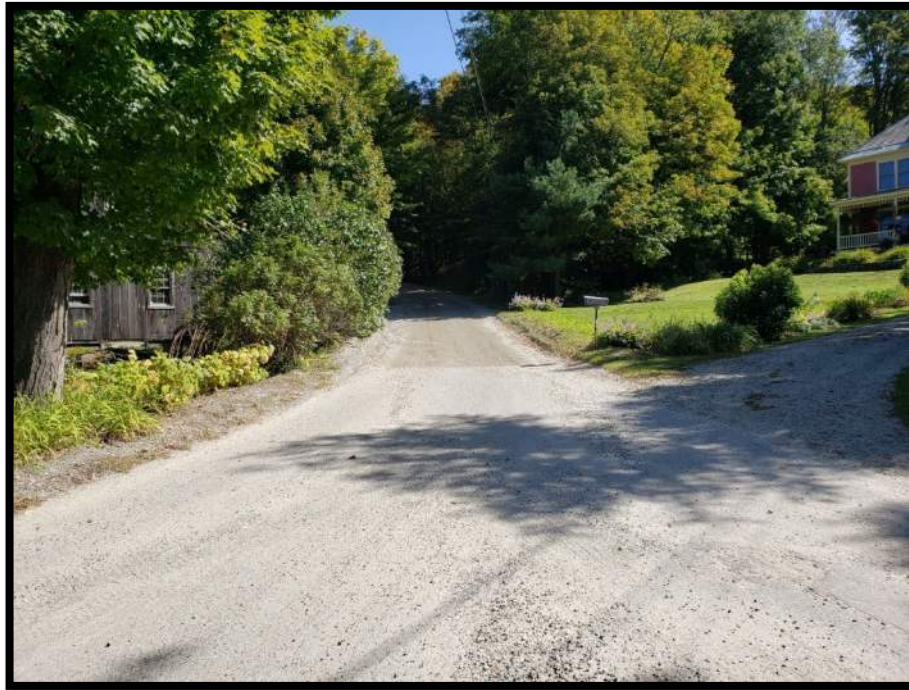
Pavement Limit and House #4 Drive

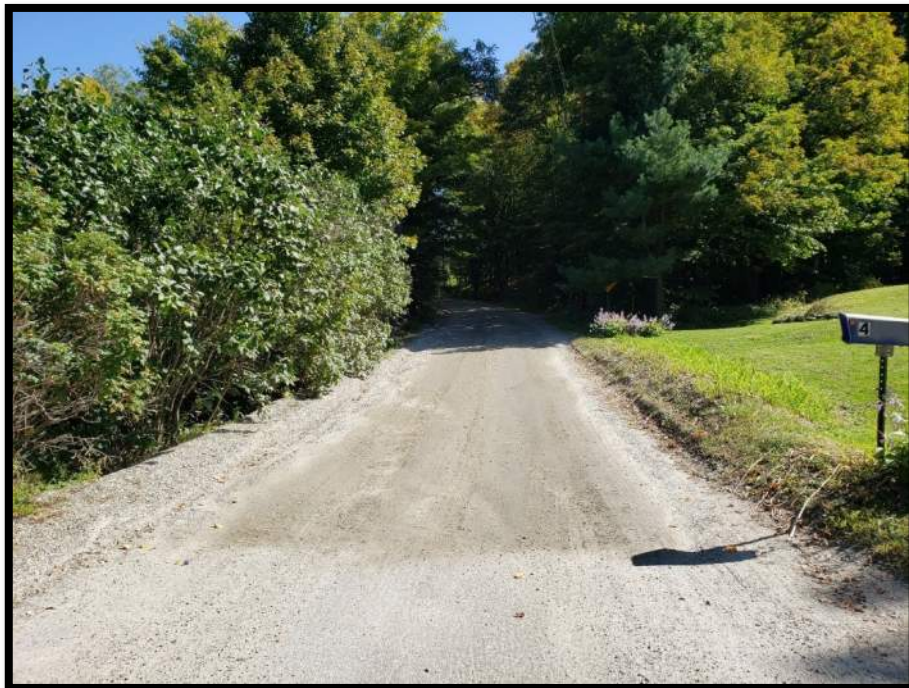
Pavement Limit (Looking East)

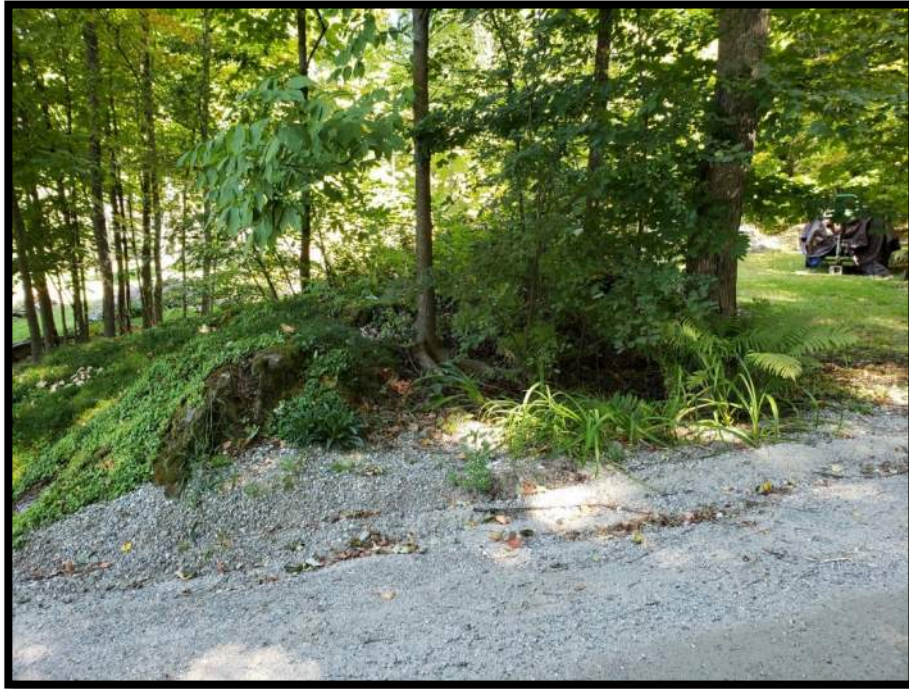
Rilling in Shoulder Gravels

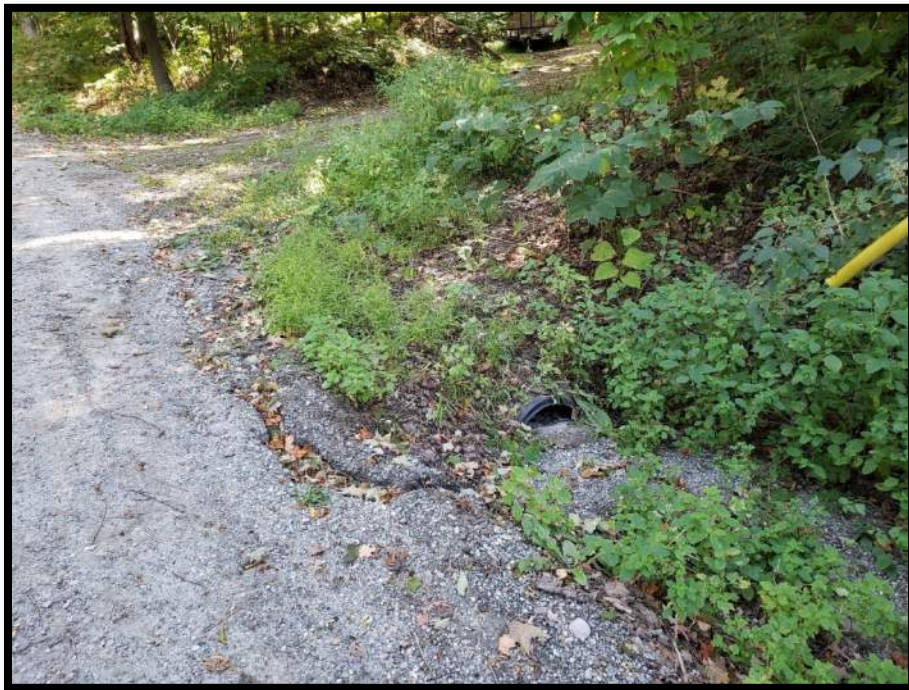
Drive Pipe and Rilling along Shoulder

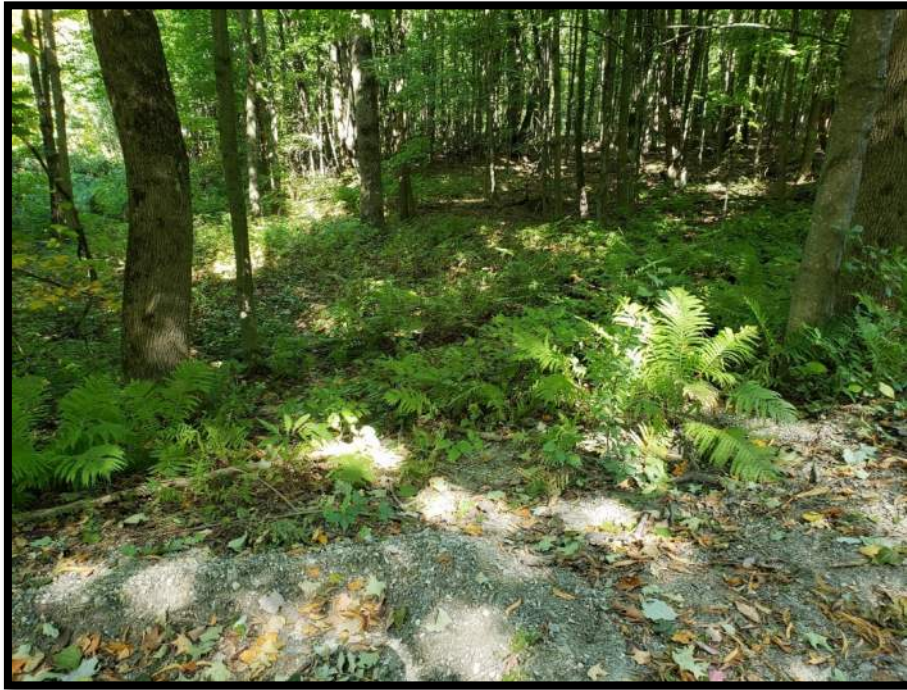
Proposed Stormwater Pond Location (Behind Community Center)

The underground infiltration system would consist of underground chambers to provide detention of the stormwater while allowing, at minimum, the water quality volume to infiltrate into the ground. The above ground bioretention system would consist of filter media that then allows the stormwater to infiltrate into the ground and underdrain for release of larger storms. An overflow structure and pipe would be provided for both systems, to discharge larger storm events, and connect to a downstream catch basin on the northern side of the Town Green. The outlet pipe would run beneath the Town Green, with limited impact to the existing trees. Pretreatment would be provided for the stormwater flowing to the system. During the design phase, a capacity analysis of the existing downstream drainage system would be required.

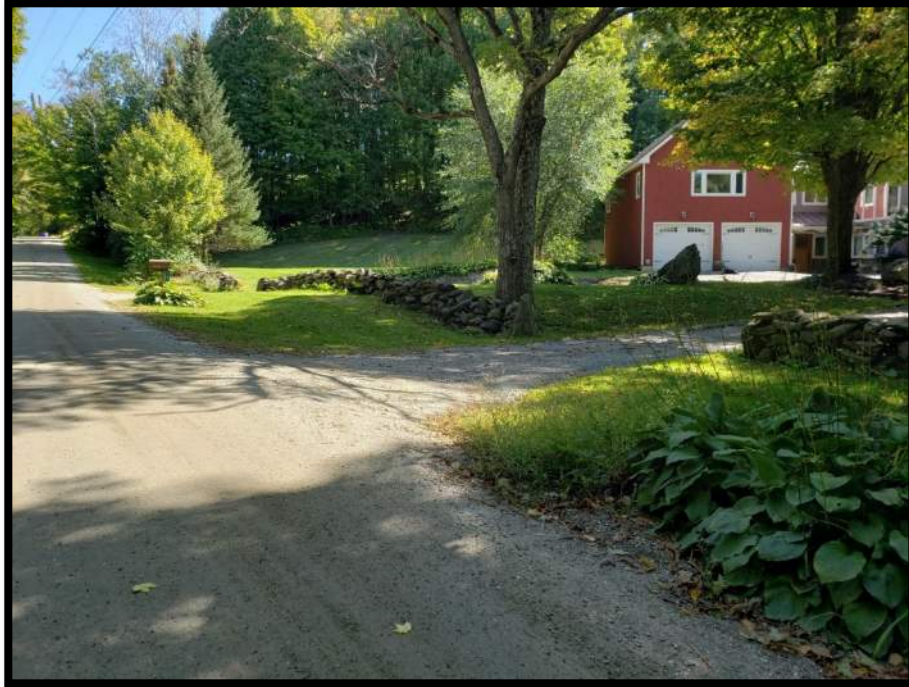
Western Drive to House #12

The project begins at Jericho Center Circle and extends approximately 650 linear feet along Bolger Hill Road to a relatively flat section of roadway just past the upper drive to House #12 (station 105+75). A causation assessment to establish the origin of the gravel that gets washed onto Jericho Center Circle during large rain events was performed for the project area and is summarized as follows. Generally, we found two likely sources for the washed gravel: the drive to House #4, and the non-compacted shoulder gravel along the project section of Bolger Hill Road.

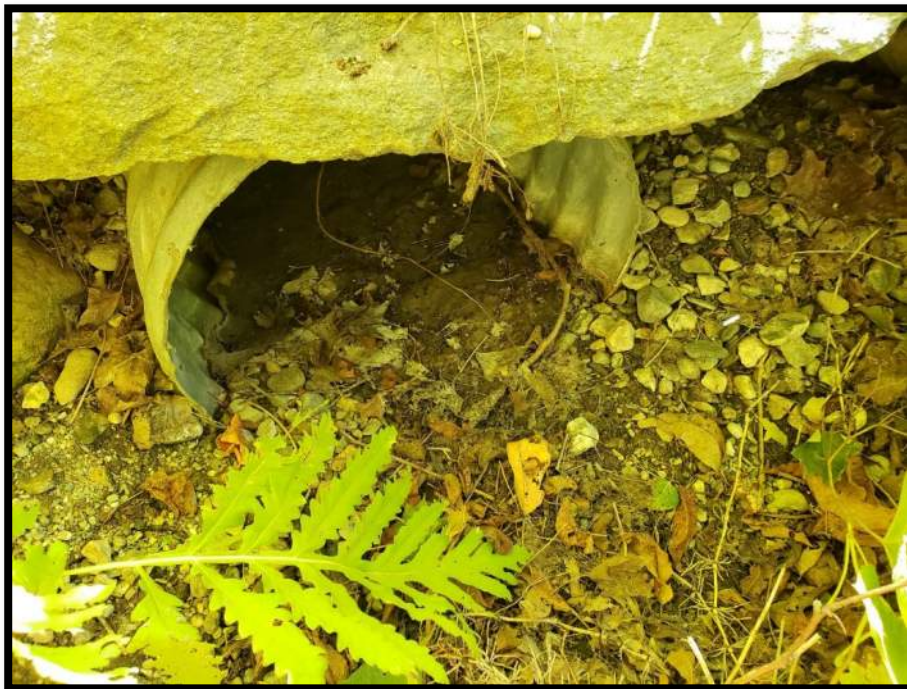
Outlet to an Existing CMP

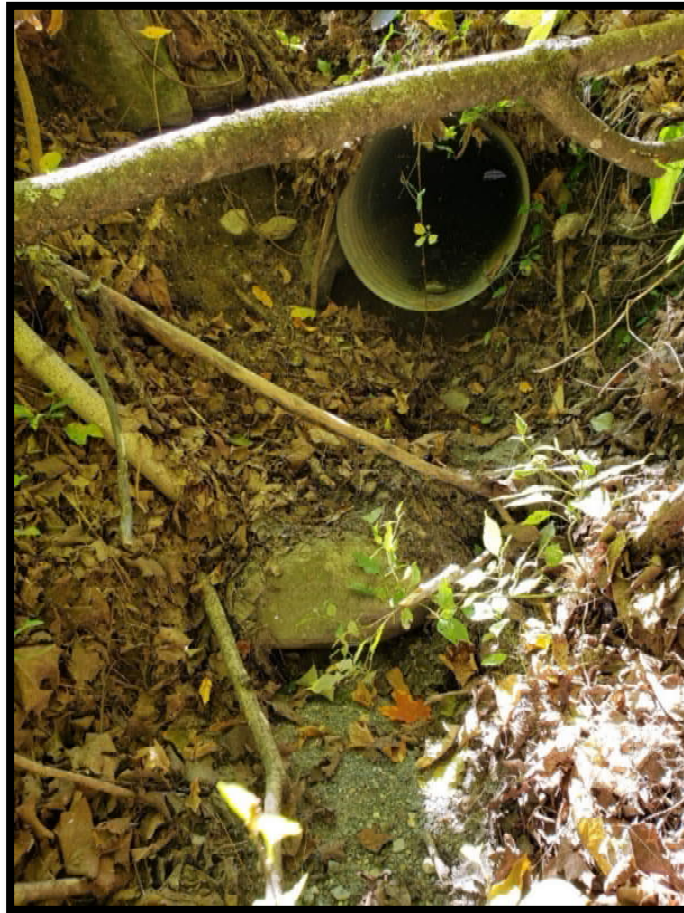
Eroded Outlet to an Existing CMP
